Walk Around

US Tank Destroyers

By Jim Mesko

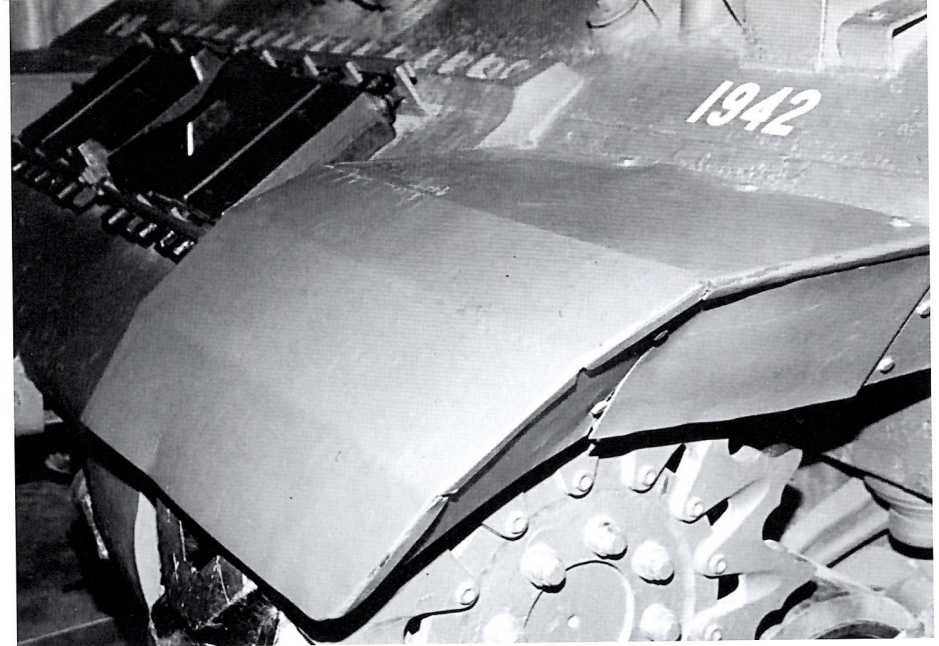
Sheet metal fenders and side skirts were attached to the hull to keep down dust and mud. They were easily bent or ripped off in the field and were seldom replaced. Both the fenders and dust shields were attached using small bolts. (Ward)

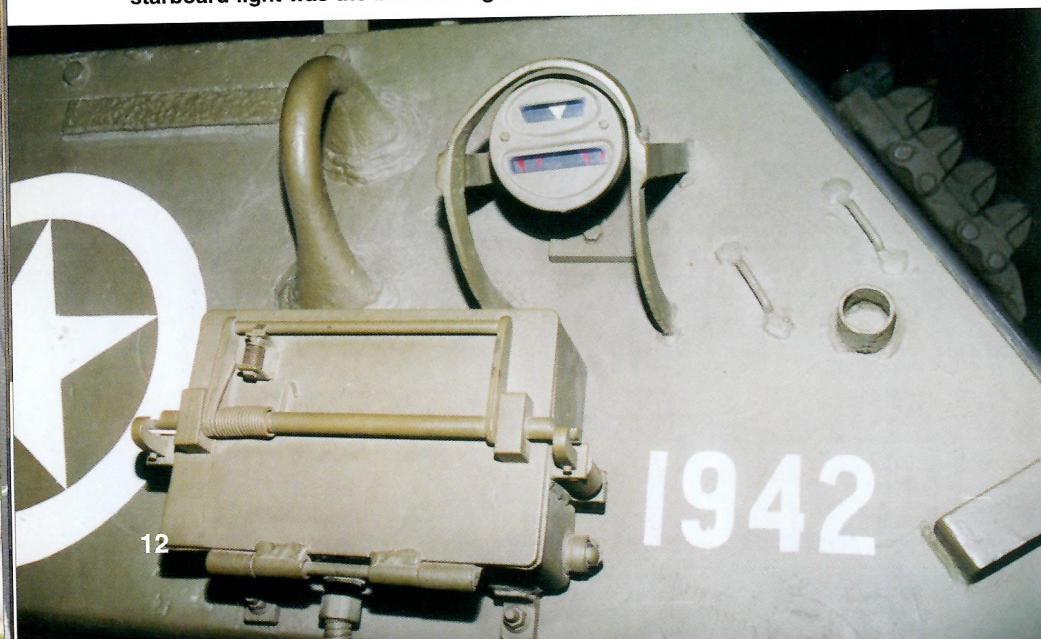
The lift ring is identical to those on the front hull, with foundry numbers stamped on the ring's side. The taillight is attached to a small plate, which is bolted onto the hull. A steel strap guard welded directly to the hull protects the light. The red taillight was used for daytime driving. The curved shovel holder is mounted to starboard of the lift hook. (Ward)

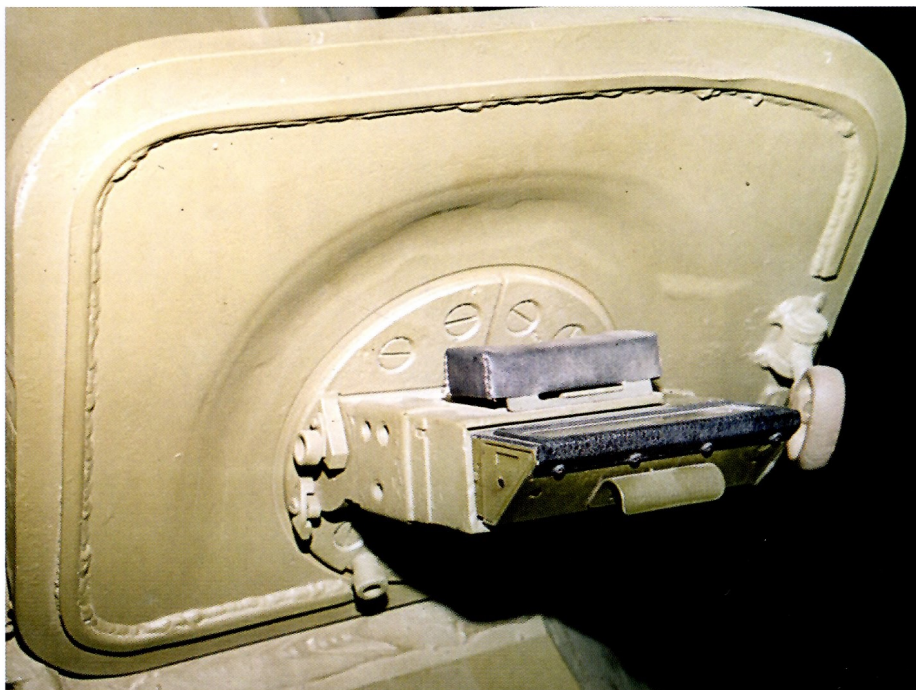
The brush guard protected the periscope from errant crew feet or branches sweeping across the top of the hull. Its angular shape provided good protection without taking up too much room. This was important since the periscopes had to swivel to provide all round visibility to both drivers. They used the periscopes to see outside the vehicle when the hatches were closed due to enemy action. This severely reduced the amount of visibility compared to looking through an open hatchway. (Ward)

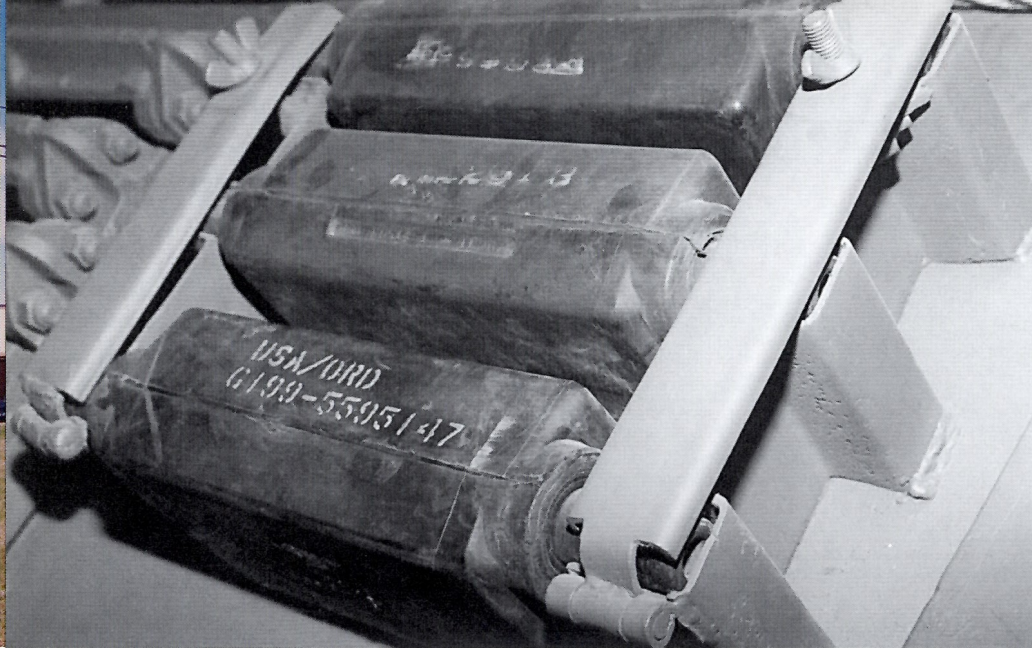
Spare track block holders like those found on the rear of M4s were often mounted on the starboard side of M36s. These holders were hinged at the bottom and swung open when the wing nuts at the top were released. The M36's track types included the T51 rubber track blocks loaded on this vehicle. (Ward)

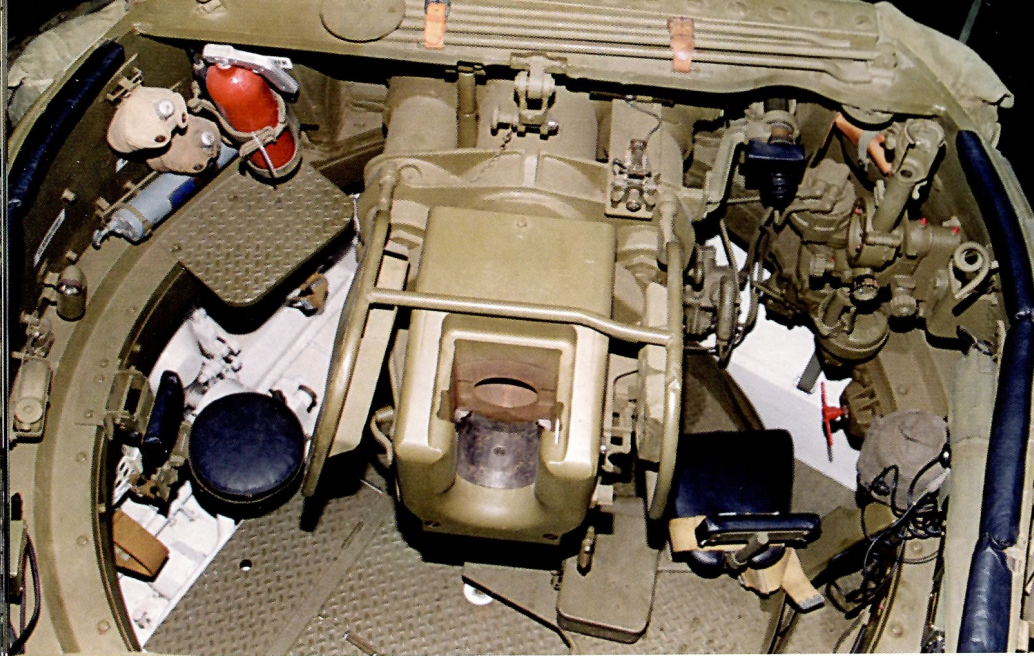
The M36 was armed with a 90MM M3 gun in an open topped turret. The loader's station is to port, while the gunner sat to starboard – a reversal of the M10's layout. The platform below the fire extinguisher was not normally found on later production vehicles. (Ward)

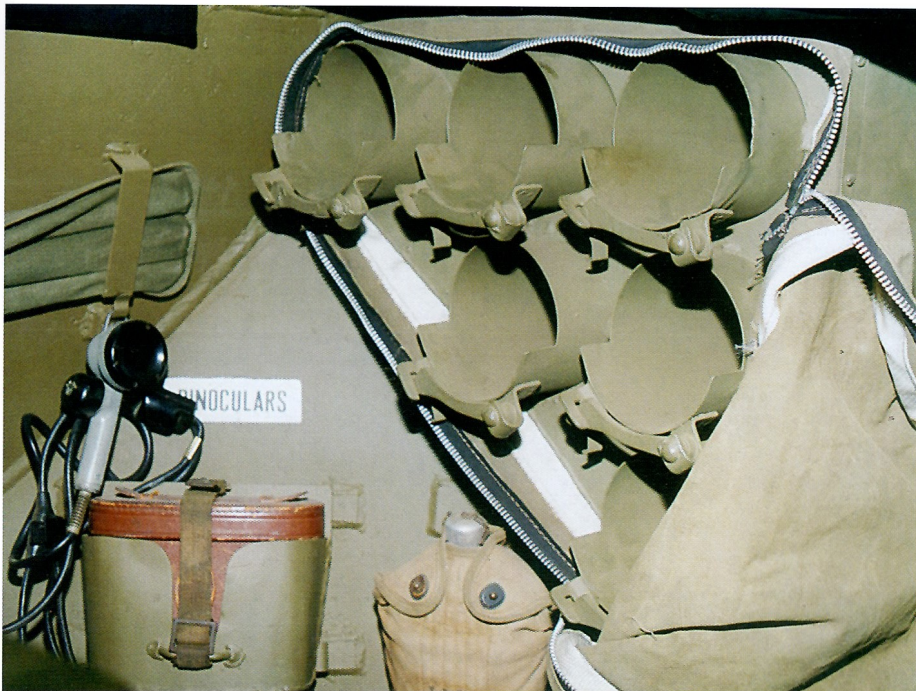
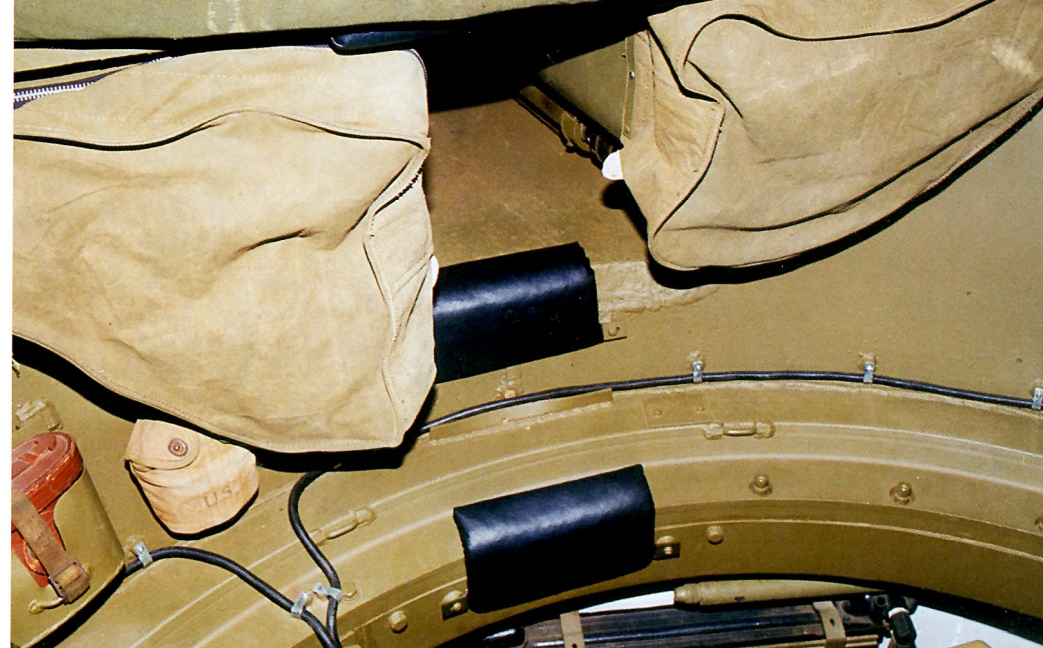
Two 90mm ammunition ready racks were mounted in the turret bustle. The racks were enclosed by sheet metal and zippered canvas covers to protect the rounds from moisture and dirt. A canvas covered canteen is secured near one of the ready racks. (Ward)

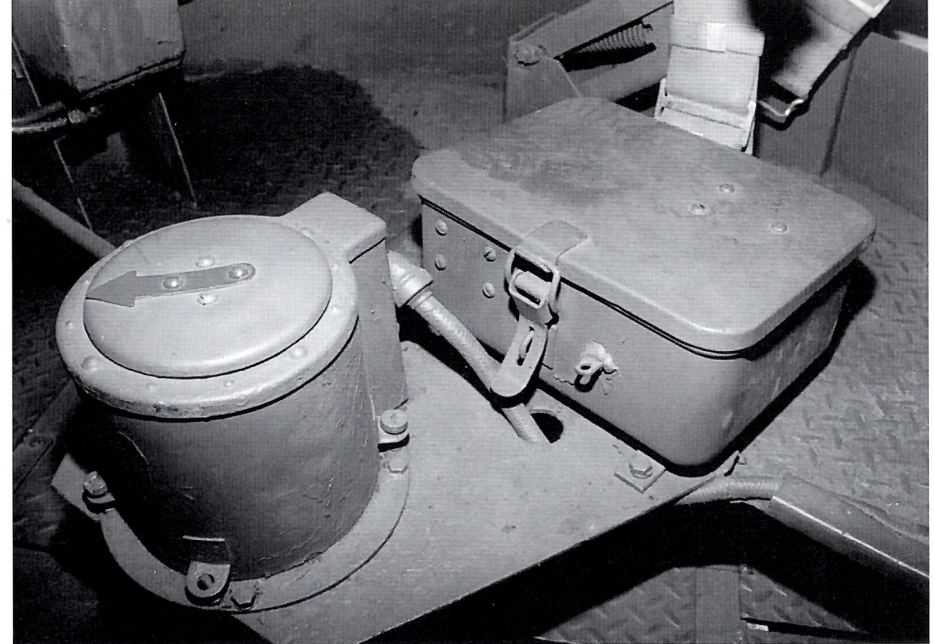
(Above Left) The turret traverse motor was located beneath the breech and gun barrel. A circuit box for the motor and the firing system was mounted on the traverse motor housing. The pistol grip controlled the power traverse and incorporated a trigger for firing the gun. The manual elevation wheel is just above the power traverse control. (Ward)

(Above) Electrical conduits connecting the turret to the hull were mounted on the turret basket floor. A power cable connected these components to the vehicle batteries located under the floor plates. The arrow riveted atop the conduit pointed to the front of the vehicle. The box next to it is a small repair kit for turret problems. (Ward)

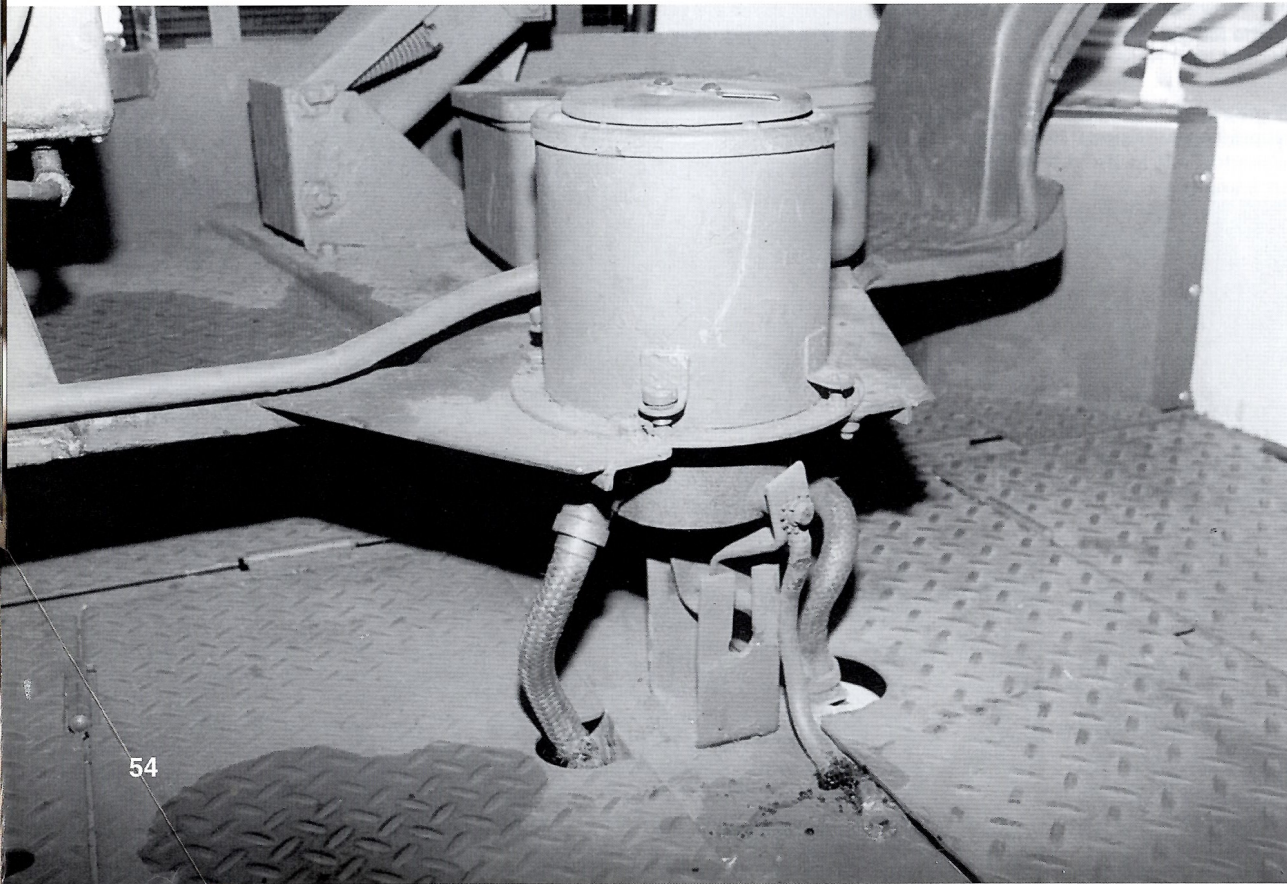
(Left) Two 12-volt batteries were located in bins beneath the floor plates. An electrical conduit is fitted on a pylon atop the basket floor. Cables run down from the conduit to the batteries. The steel floor plates are embossed with anti-skid markings. Batteries were charged from the two 30-volt main generators or from the 30-volt auxiliary generator. (Ward)

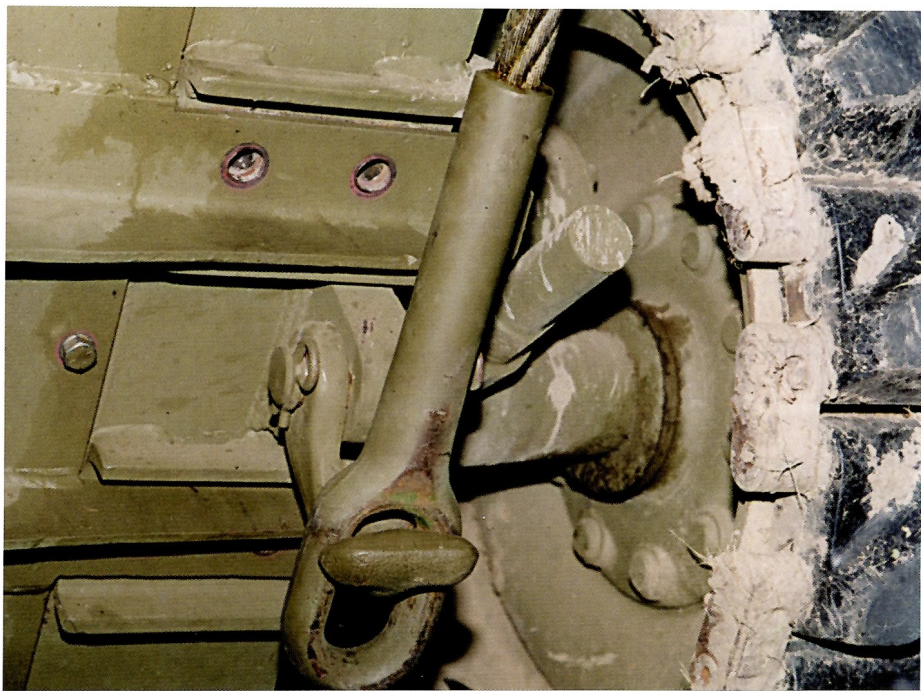
The track tension-adjusting nut was tightened or loosened by a wrench. A second nut was used to lock down a wedge shaped retaining bar over the tension nut. Proper tension was achieved by placing blocks of wood between the second and fourth return rollers and the track. The nut was adjusted until the track barely touched the third return roller. (Ward)

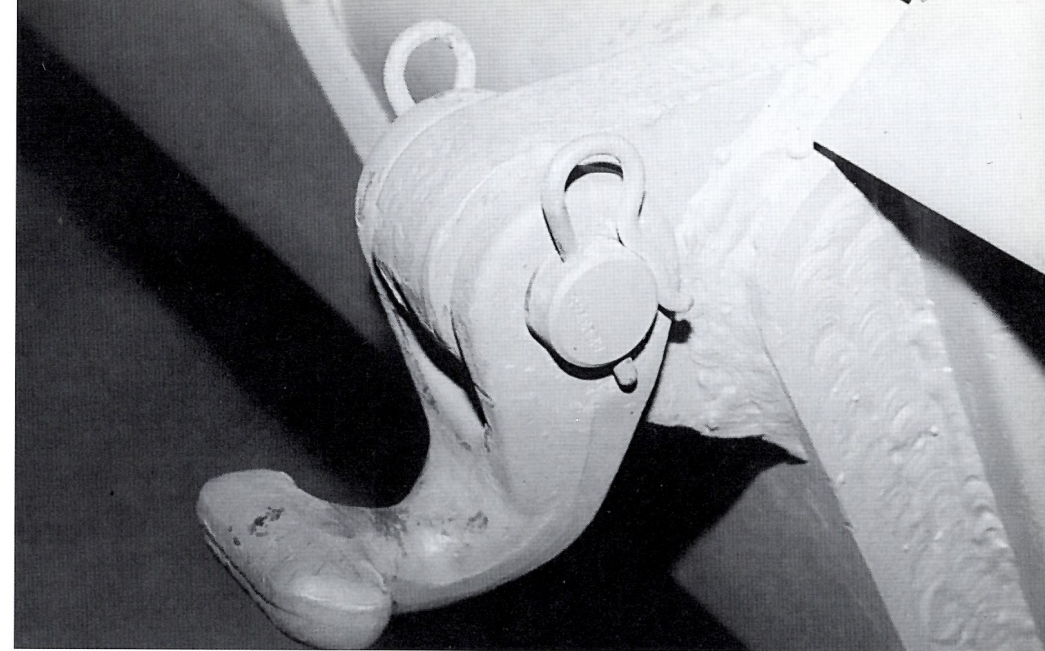
Tow shackle mounts were welded to the front corners of the hull. Large cotter pins were used to secure the pins that held the U- or L-shaped shackles in place. Tow cable heads were slipped over the shackles when the M18 was engaged in towing operations. (Ward)
